# “But I’ve always done it this way.” Technical support – it makes a difference\*

STEWART GRICE

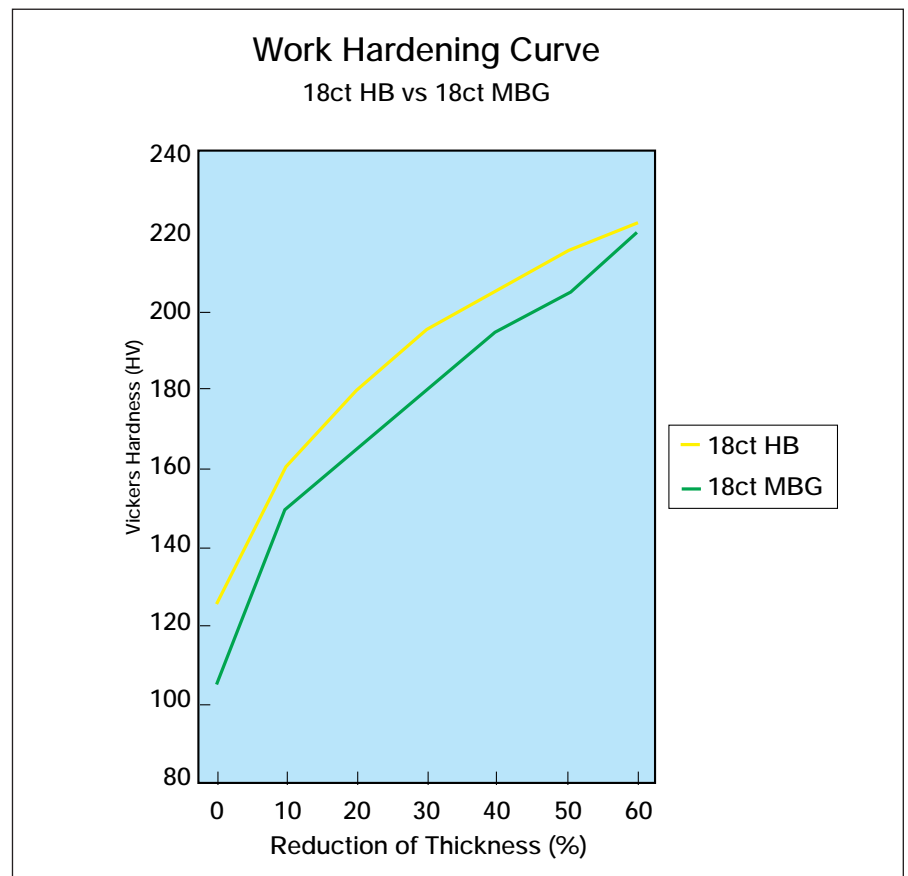
Figure 1 - Work hardening curves of 18ct HB and MBG alloys

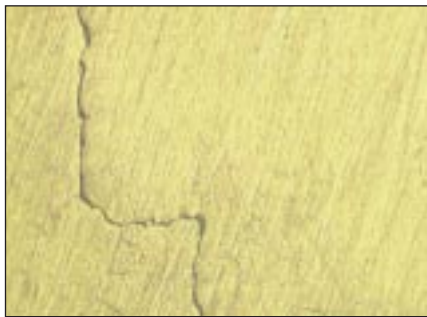
**Figure 2** - Intergranular cracking in 18ct yellow gold alloy HB sheet. x30

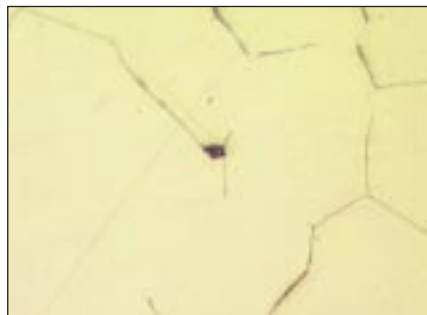
**Figure 3** - Presence of grey phase at grain boundaries in 18ct HB alloy sheet. x800

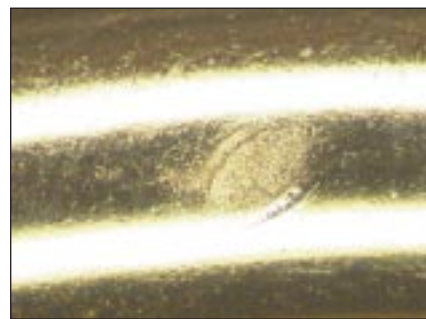
**Figure 5** - Blemish on the surface of a 9ct DF alloy hoop earring. x30

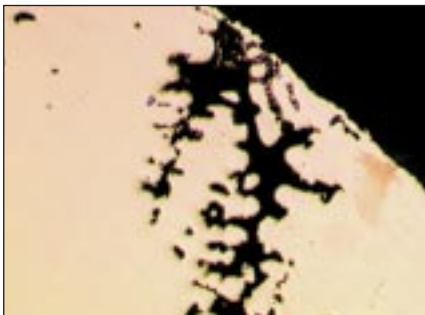
Figure 8 - Shrinkage porosity in cast 9ct red gold alloy AA460. x320

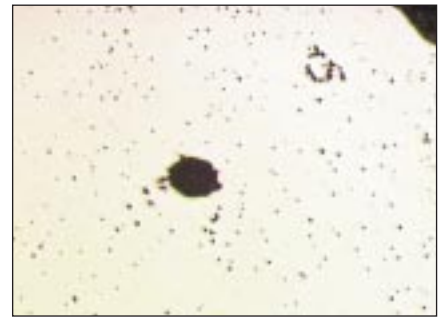
**Figure 10** - Large gas pores and gas porosity in cast 9ct gold alloy AA460. x160

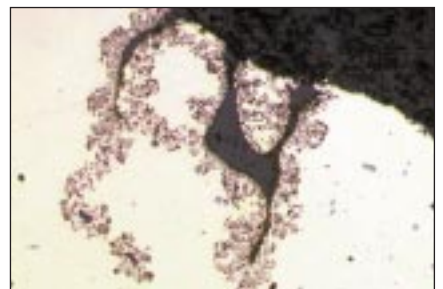
**Figure 12** - Chlorine reaction at surface of casting, 9ct AA460 alloy. x320
