HANDBOOK ON CASTING AND OTHER DEFECTS

In Gold Jewellery Manufacture

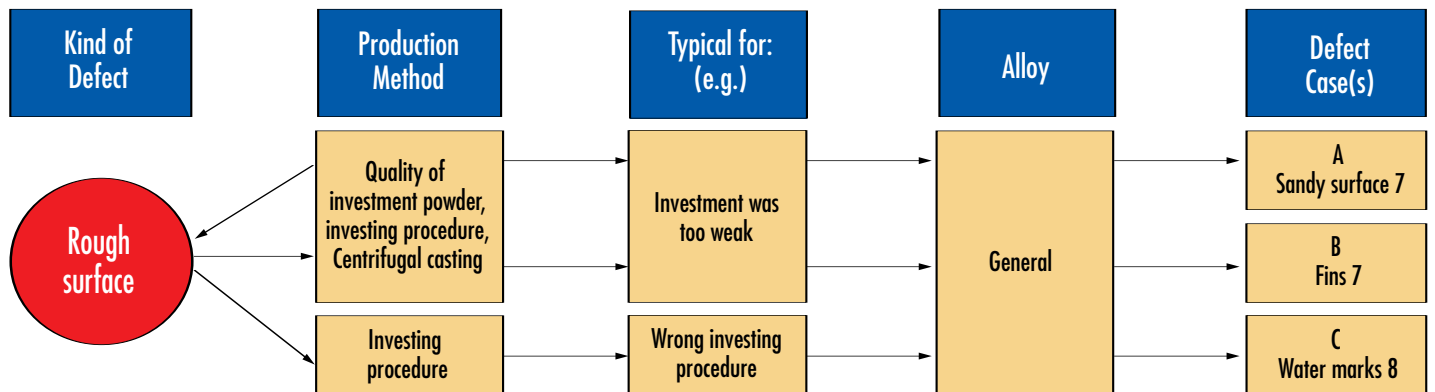
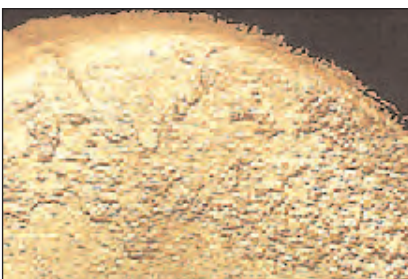
Defects caused by investment or investing process

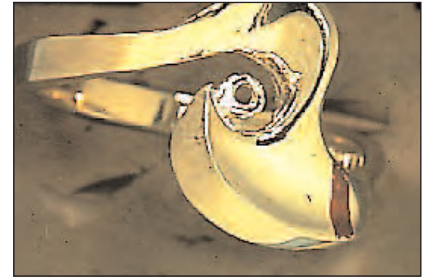
Fig. 1.1 The polished surface

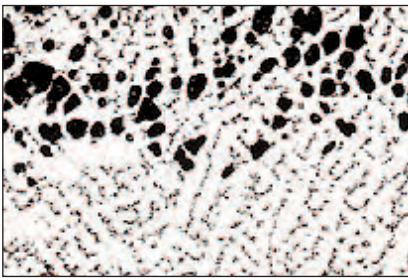
Fig. 1.4 Detail of fig.1.3, gas pores at higher magnification 50 x

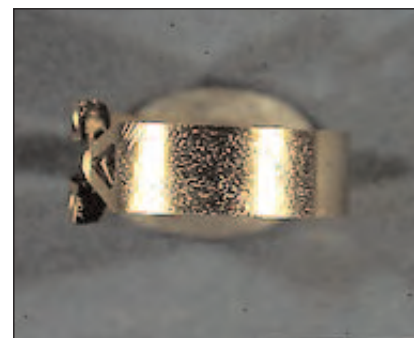
The cause of this type of defect is not well understood. A possible explanation is that abundant inclusions of copper oxide decompose when the melt is about to solidify, releasing oxygen and forming gas pores. Whether other factors such as the presence of reducing agents (old investment/sulphides) play a role is not clear. Further study is necessary.

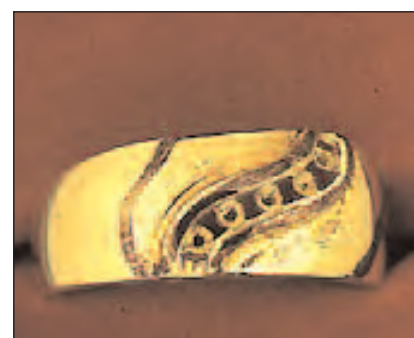
Fig. 2.2 Another example of the same kind of defect

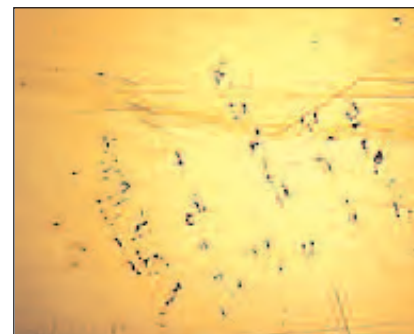
Fig. 2.3 Typical example at higher magnification 100 x

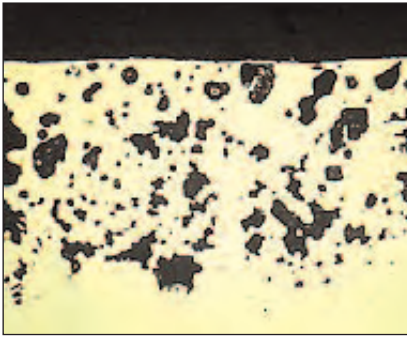
Fig. 2.5 Microstructure of a ring with a porous surface. 50 x

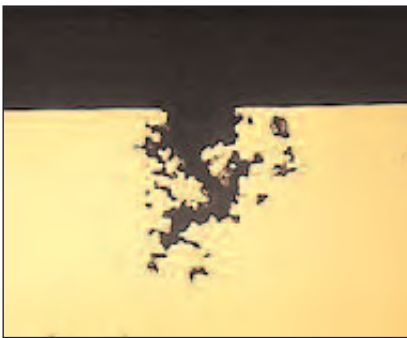
Fig. 2.6 Another example. 200 x

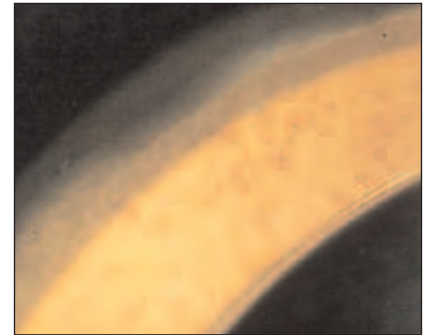
In this case, the use of 60% of recycled metal in the new charge is

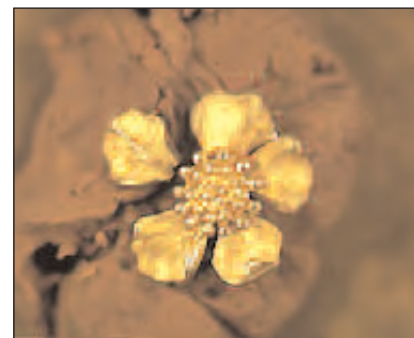
The defect is a exemplary case of shrinkage porosity in terms of appearance and the cause. It must be noted that liquid (molten) metals

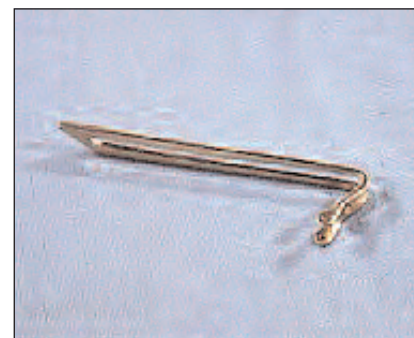
The gate might be better attached to this thicker part of the clip, thus alleviating this problem. However, there is a high probability that shrinkage porosity will now occur at the opposite end for the same reason. There is

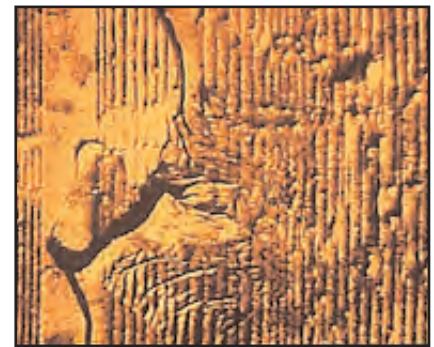
Formation of cold shuts can be avoided by increasing the casting and/or the flask temperatures but restricted to the minimum amount necessary to avoid the occurrence of other kinds of defects (e.g. resulting from reactions with the investment). Material separation by films of zinc oxide can only be avoided by using clean material and a protective atmosphere.

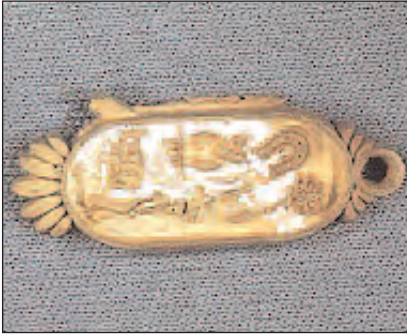
Fig. 7.4 Pendant in 14ct gold

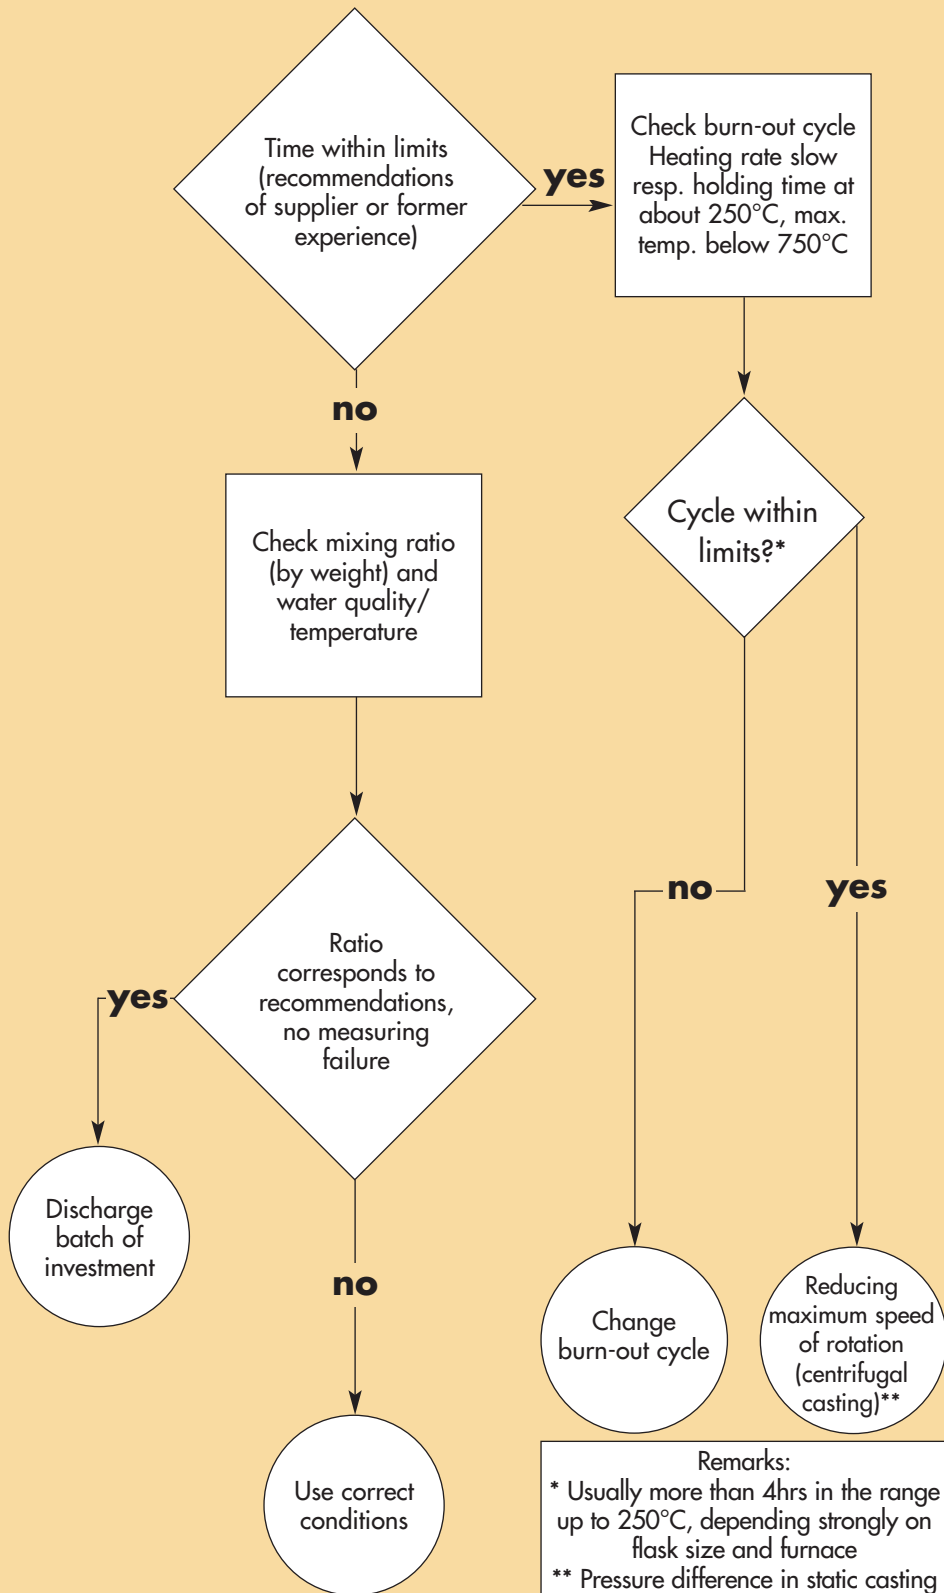
Remarks:
 * Usually more than 4hrs in the range up to 250°C, depending strongly on flask size and furnace
 ** Pressure difference in static casting has no significant influence

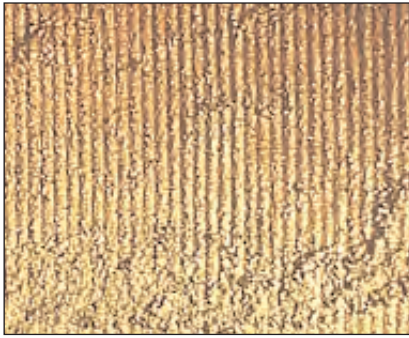
Fig. 8.1 approx. 20 x

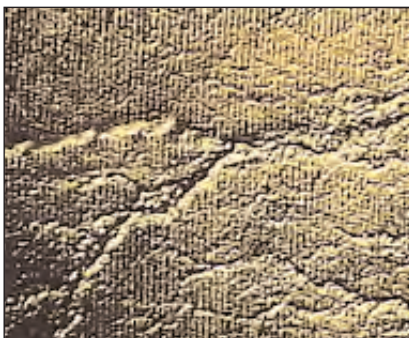
Fig. 8.2 Watermarks on test piece (piece of a record) approx. 10 x

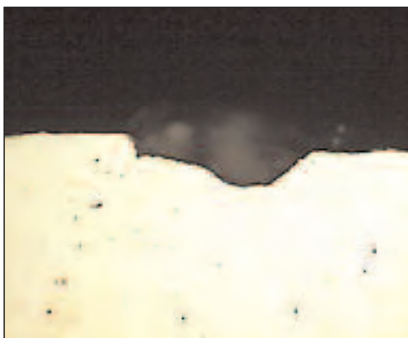
Fig. 9.1 Wrinkled surface of 14ct yellow gold ring 6 x

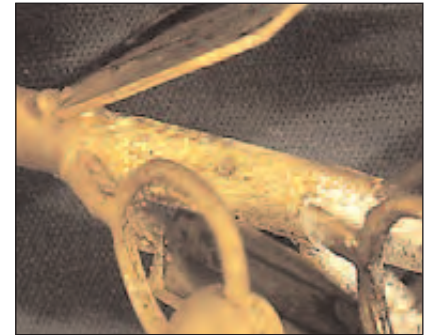
Fig. 10.1 Surface of central sprue

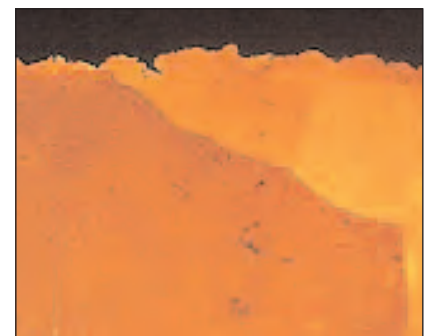
Fig. 10.3 The dendritic surface structure as revealed in a scanning electron microscope (SEM).

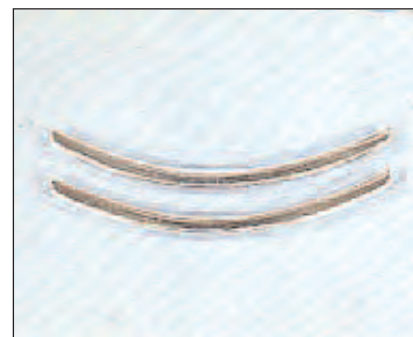
Figure 11.3 shows a pore at higher magnification. Only a small part of the defect volume reaches the surface. More polishing would enlarge the defect.

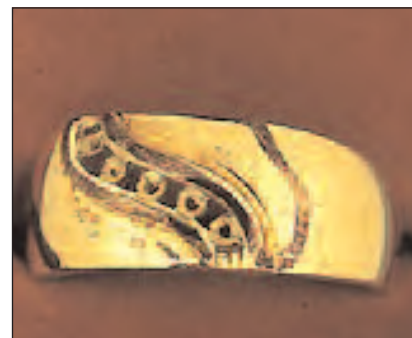
Fig. 12.1 Surface porosity caused by impurities.

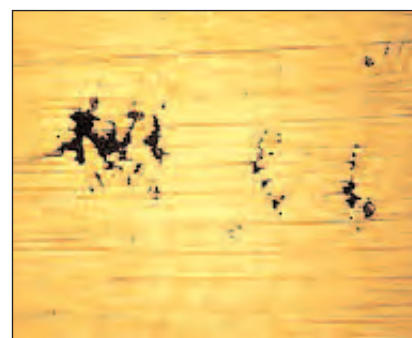
Fig. 12.2 Typical surface porosity caused by oxide impurities in a high zinc-containing alloy.

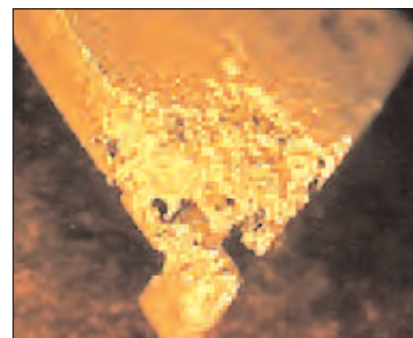
The cause of the defect are external impurities introduced into the melt. At least some of the impurities were liquid (slag) at the moment of casting and are swept into the flask where some float to the surface of a cast item while the metal was still liquid. After solidification, this typical cauliflower-like structure of the metal surface remains, while the slag particles themselves are removed during the cleaning of the casting. However, not all the slag (or inclusions) collect on the surface. Some of it forms inclusions close to the surface. The shape of the inclusions and their analysis by SEM-EDX can provide reliable information on the origin of defect.

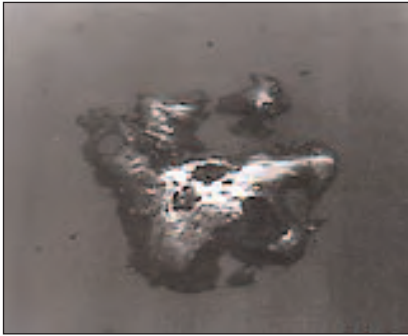
Fig. 13.5 Another example of a silicate inclusion.

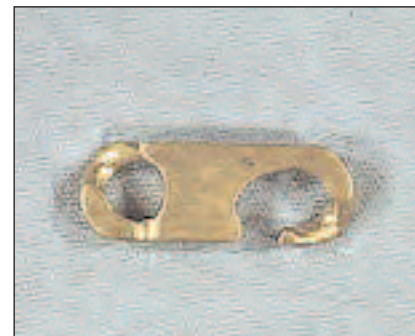
Fig. 14.1 A spring hook with surface porosity

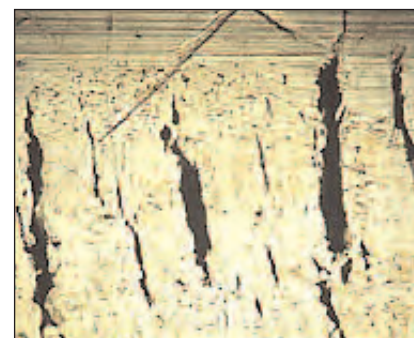
Fig. 15.1 Surface of the ring approx 20 x

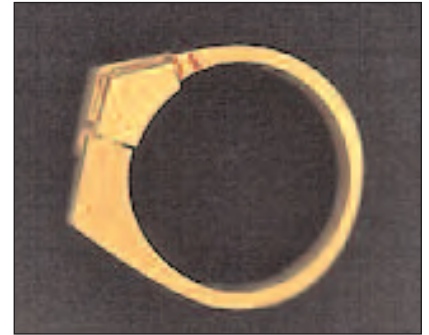
Manufacturing Method: The defect is not primarily a casting defect; the composition of the alloy is the decisive factor. However, it occurs almost exclusively with some specially formulated casting alloys.

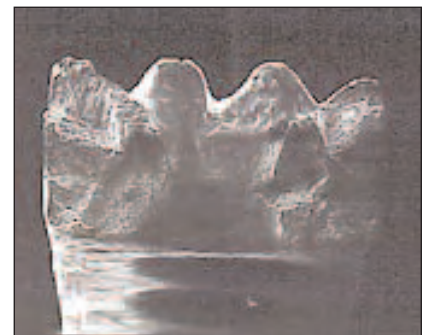
Fig. 17.4 SEM of fracture surface

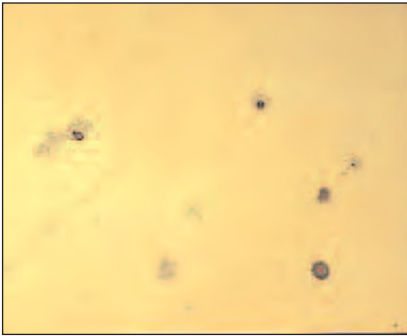
Fig. 17.5 Inclusions in a broken 14ct yellow gold sample

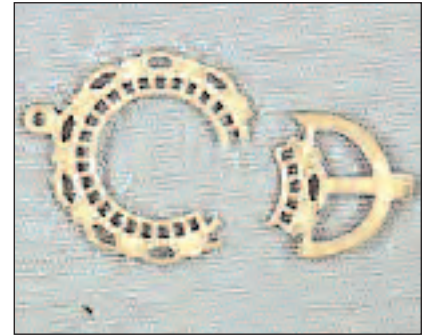
Fig. 17.8 A pendant, broken after de-vesting

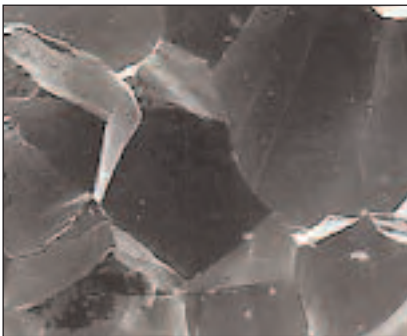
Fig.18.2 SEM: fracture surface of a lead-containing 18ct alloy

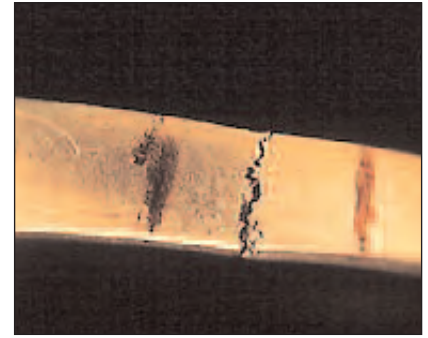
Fig. 19.1 A broken shank of an 18ct yellow gold ring

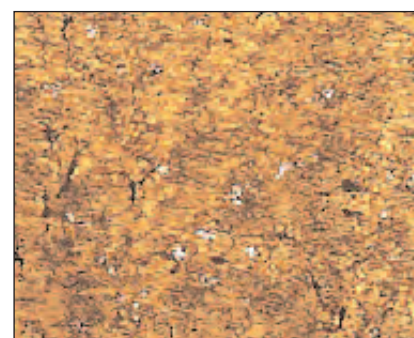
Fig. 20.4 Nests of iridium inclusions in a 21ct alloy

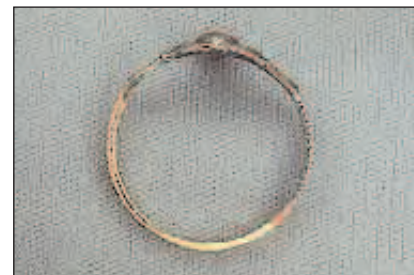
The best way to avoid tarnishing is through use of higher carat gold alloys. Otherwise, a practical way to prevent low carat gold from tarnishing is by electroplating the pieces with fine gold or high carat gold with a sufficient thickness. This is not a permanent solution, however, as the electroplated layer will be eventually worn away. On storage, tarnishing can be prevented by keeping the jewellery pieces in a dry environment and avoiding contact with sulphur-containing boxes.

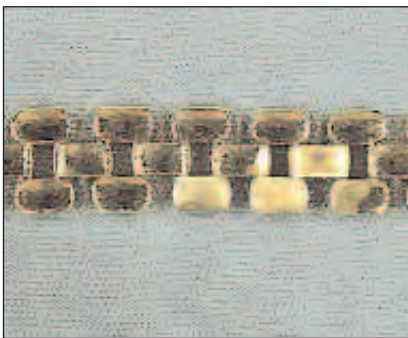
Fig. 22.2 This example shows the stained surface in more detail

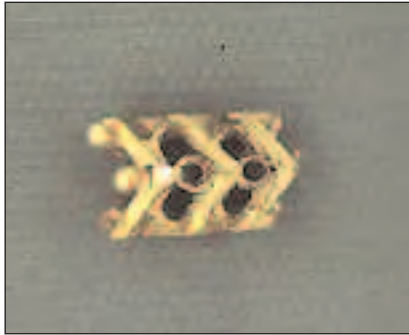
Fig. 23.1 Fractured 14ct gold ring

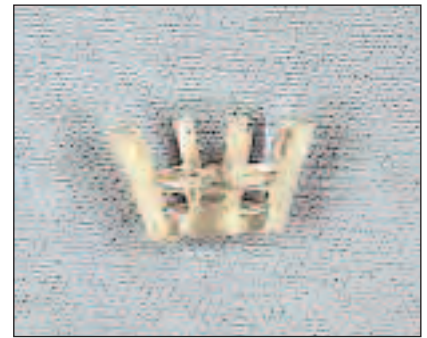
Fig. 24.1 Broken prong on a white gold finding

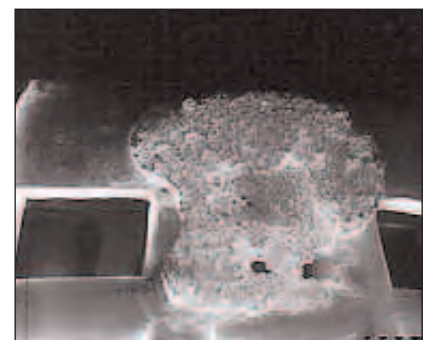
Fig. 24.2 SEM image of the fracture surface

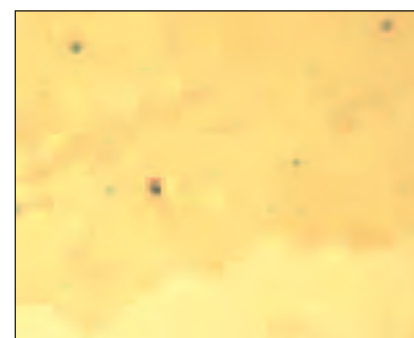
Both binary gold-copper alloys and gold-copper-silver alloys are sensitive to the age hardening phenomenon. The extent of age hardening depends strongly on the copper/silver ratio and the caratage. Pink and red gold alloys with high copper contents are especially sensitive. Note: High carat golds (21/22 carats and higher) are not affected by this phenomenon.

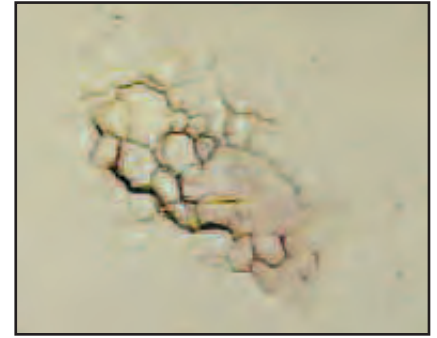
Fig 26.1 Polished and annealed surface, 18ct yellow gold 200 x
